**Technical Service  
BULLETIN**

**M.I.L. "ON" DTC P2714 WITH  
TRANSMISSION PERFORMANCE DTCs**

'07 Tundra

TRANSMISSION & CLUTCH  
TC017-07

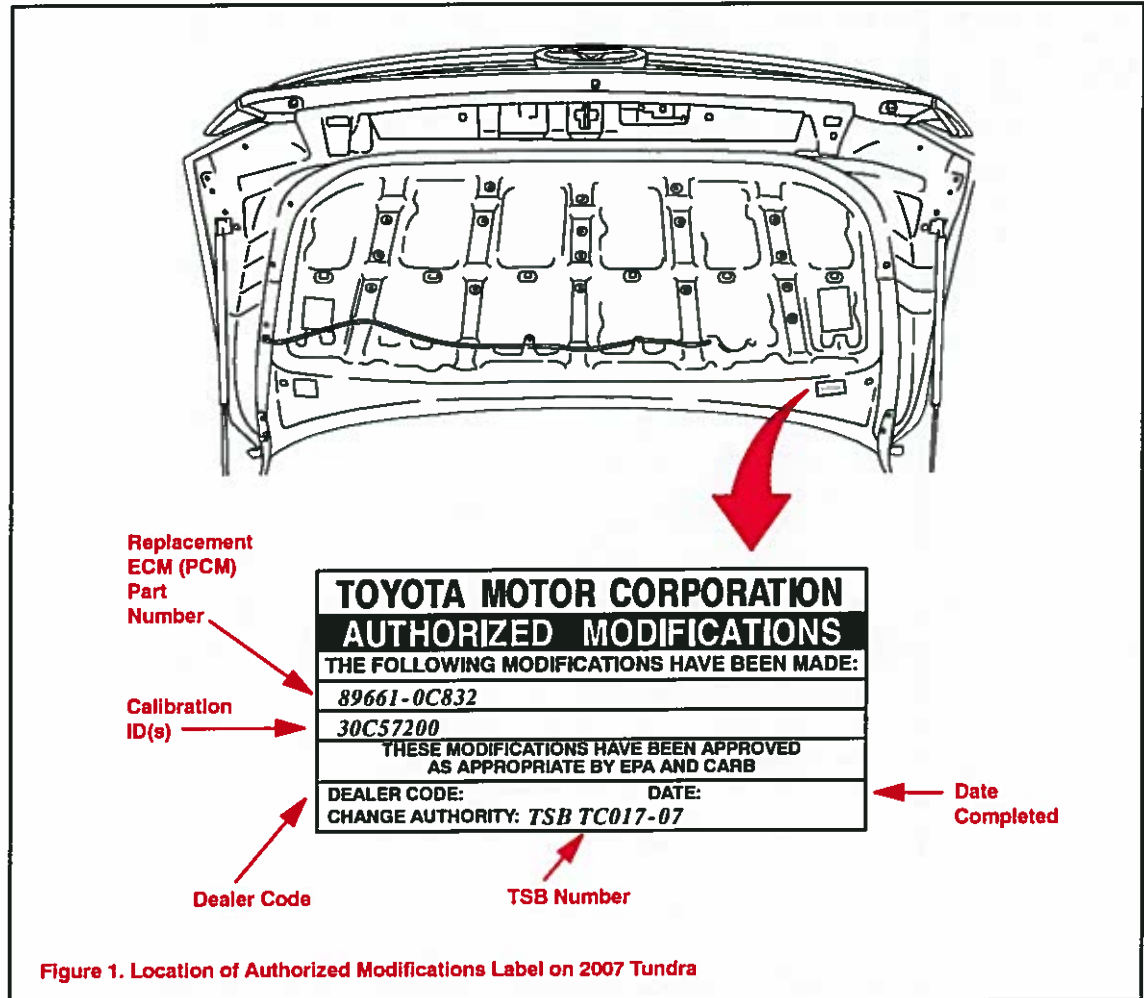
6. Check for the Authorized Modifications Label affixed to the vehicle in the location shown in Figure 1. Confirm if the ECM (PCM) calibration has been updated. If the calibration ID listed is NOT the latest ECM (PCM) calibration — go to step 7.

- A. Using a permanent marker, enter the following information on the label:
  - ECM part number: *[Refer to the **Parts Information** section for the **CURRENT PART NUMBER**]*
  - Calibration ID(s): *[Refer to the **Calibration Identification Chart** for the **NEW CALIBRATION ID**]*
  - Dealer Code
  - Repair Date
  - Change Authority (this TSB number): *TC017-07*
- B. Affix the Authorized Modifications Label to the vehicle at the location shown in Figure 1. The Authorized Modifications Label is available through the MDC, P/N 00451-00001-LBL.
